## REFERENCE PANELS

# GUIDANCE NOTES ON CONCRETE FINISHES to The Specification for Highway Works

## LONDON SOUTH (External Site)

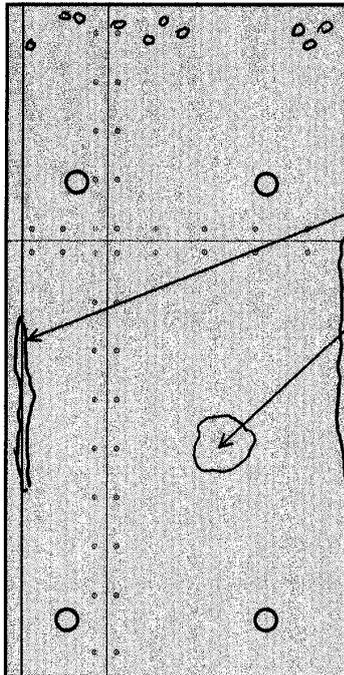
**Panel 1**                      Finish Class F2  
**Side 2**                      Birch ply formwork

Discolouration caused by moisture loss at chamfer/form interface – ensure form joints do not leak.

Area of small blow-holes

Chamfer clean and well defined.

Occasional irregular cavities lined with aggregate particles (at the top), aggregate bridging, a function of coarse aggregate grading. Re-vibration of upper third may have minimised this.

Colour variation and some fines loss caused by moisture loss between plastic tie-bolt cone and form face – ensure form joints do not leak.

Tie-bolt holes generally clean and well defined.

*Overall finish considered Class F2*

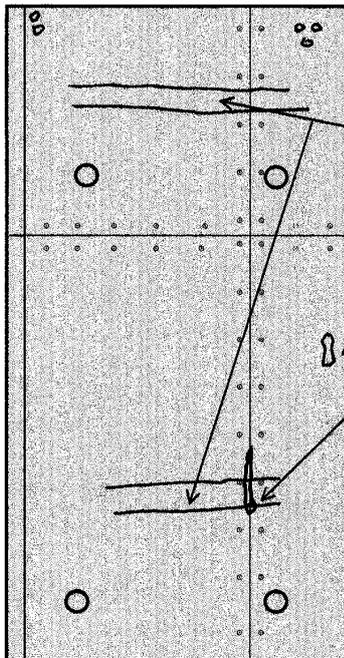
**Panel 1**                      Finish Class F4  
**Side 2**                      Medium Duty Overlay formwork

Discolouration caused by stacking of panels with timber spacers locally affecting the curing compared to the rest of the panel that was open to air circulation.

Minor damage to form face from vibrating poker – poker burn – poor workmanship.

Discolouration caused by moisture loss at butt joint interface – ensure form joints do not leak.

Chamfer clean and well defined. Concrete reflects the sealant shape and some residue sealant visible – poor workmanship.

Occasional irregular cavities lined with aggregate particles (at the top), aggregate bridging, a function of coarse aggregate grading. Re-vibration of upper third may have minimised this.

Tie-bolt holes generally clean and well defined.

*Overall finish considered Class F4*

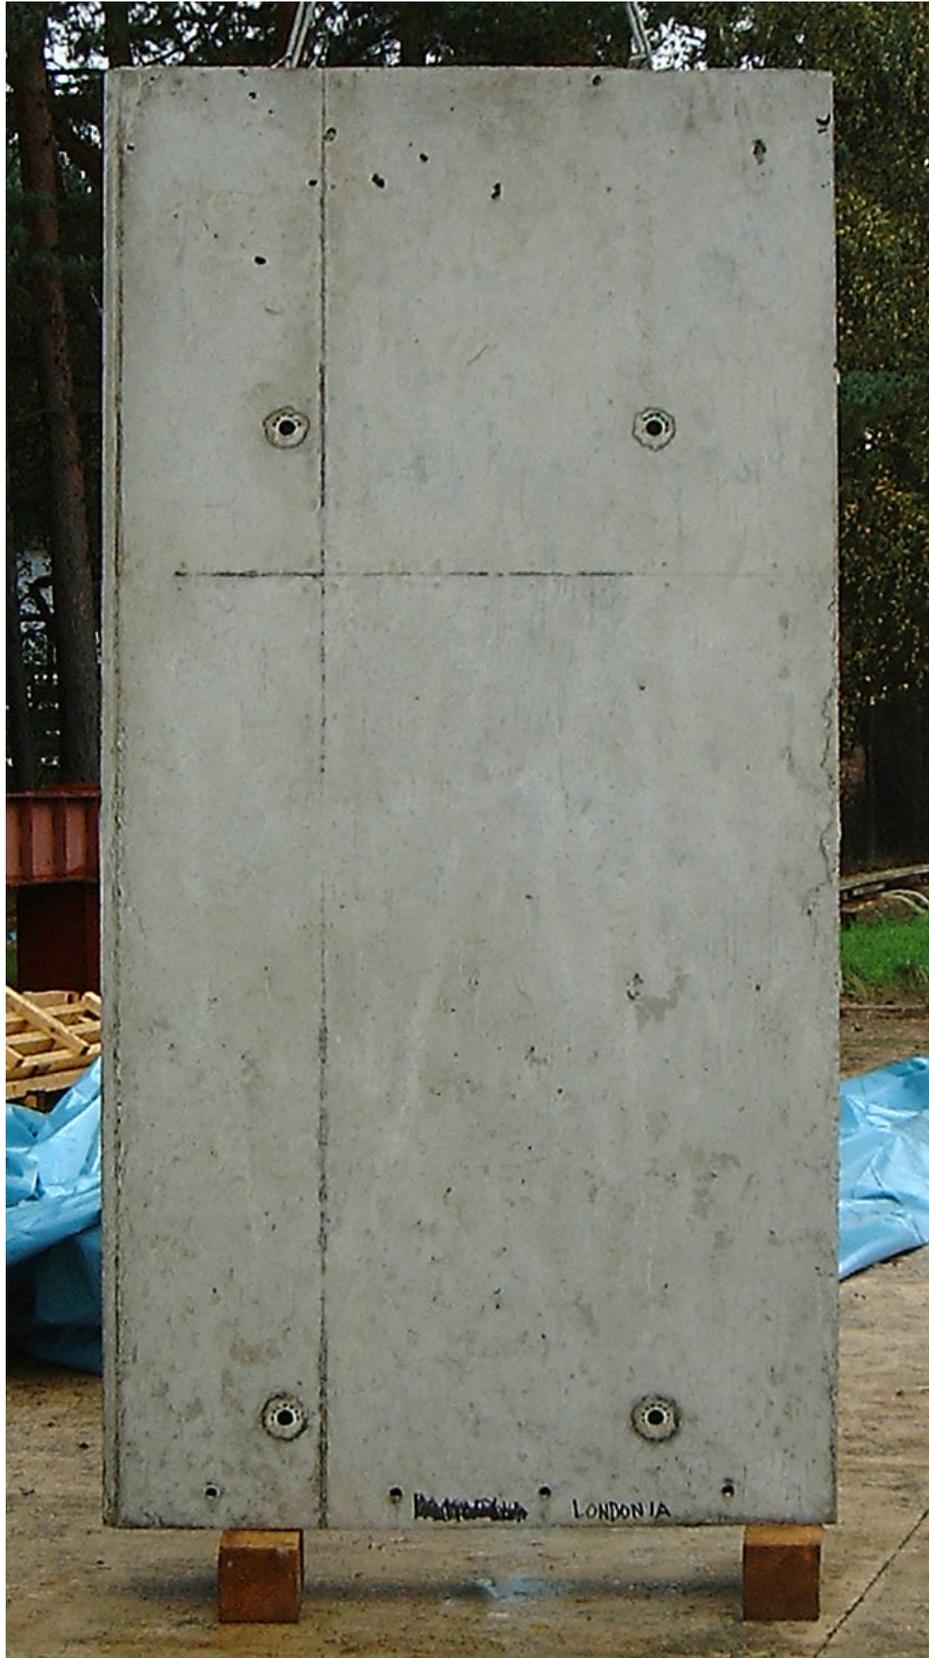
**Panel 1 - Side 1 - F2 finish**

A Class F2 finish as struck from a Birch ply form face, sealed with varnish. The butt joints between sheets were not filled. The screw heads were driven flush but not filled and the edge chamfer was not sealed against form. An imprint of the joints and screw heads is displayed as ridges and knobs, in a uniform pattern.

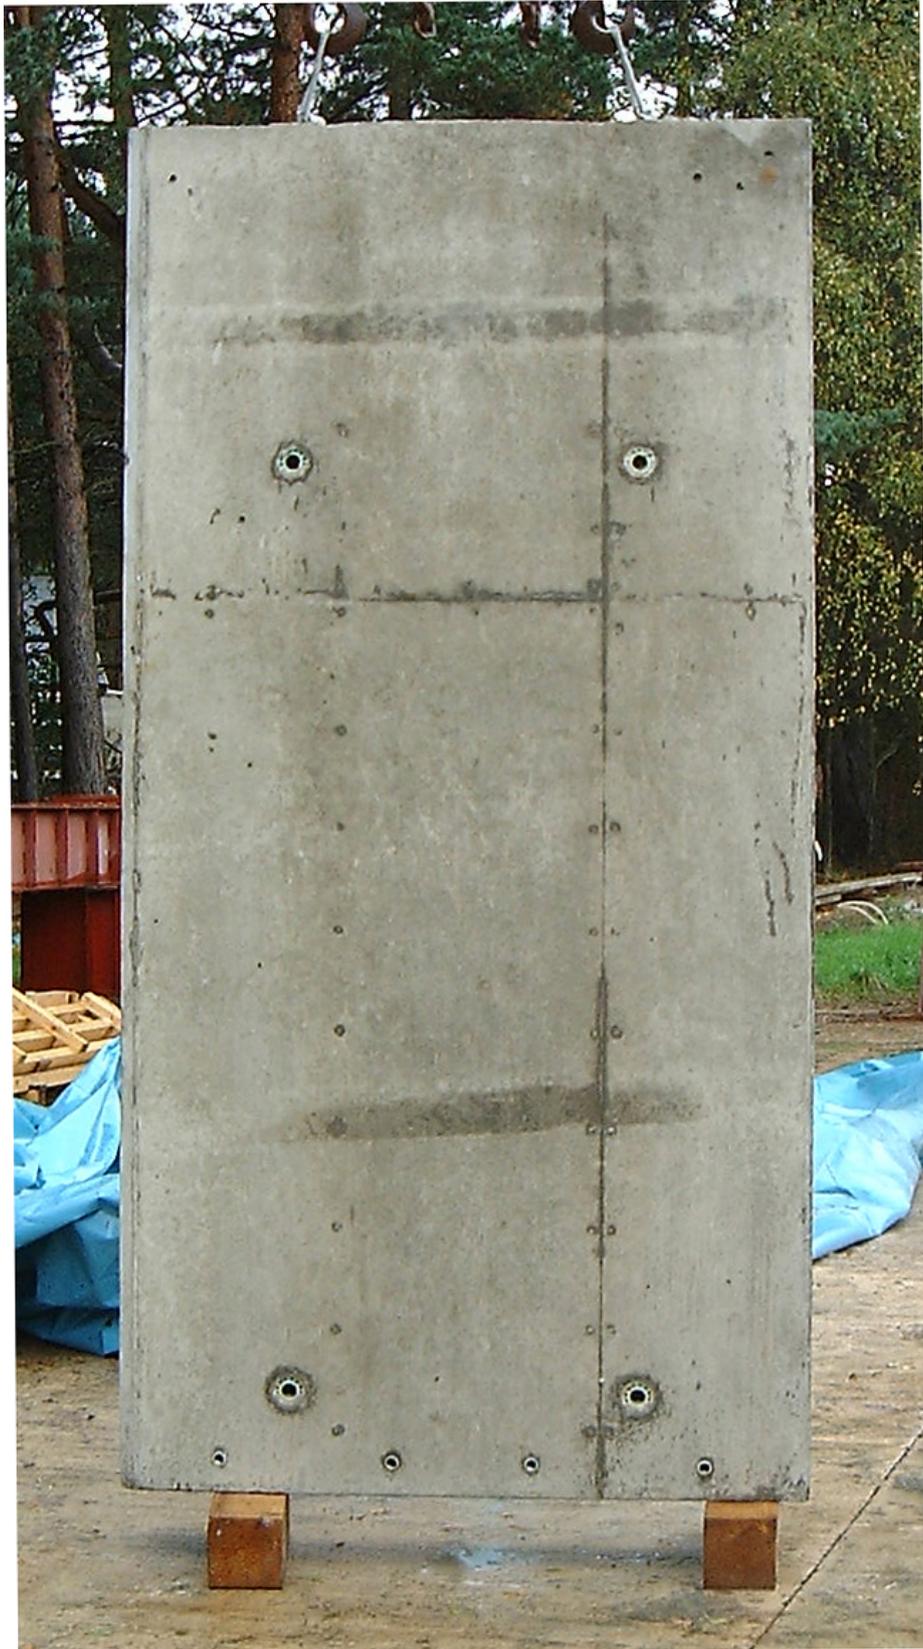
**Panel 1 - Side 2 - F4 finish**

A Class F4 finish as struck from a Medium duty overlay (MDO) type form face. The butt joints between sheets were filled and sanded. The form joints were filled with a bead of silicon sealant, as was the edge chamfer. The screw heads were counter-sunk, filled and sanded. An impression of the joints and screw heads is flush and smooth. A colour variation exists due to the difference in absorption of fill material compared to that of form face.

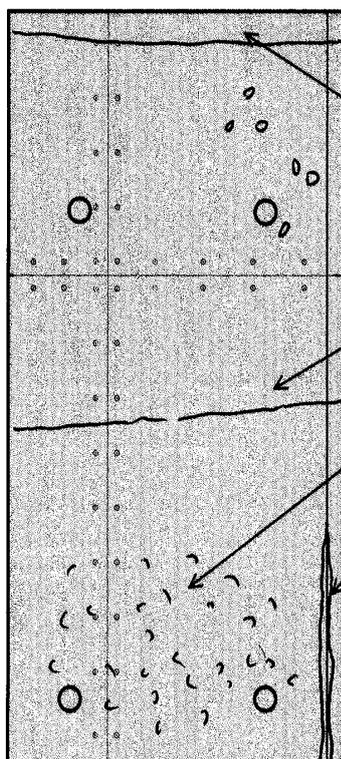
**Panel 2**                      Finish Class F2  
**Side 1**                      Steel plate formwork

Dusty surface caused by upper surface of wall not being covered to prevent moisture loss. Concrete shrinks away from form surface while immature, sometimes plucking concrete face, but leaving a dusty weakened surface – lack of early curing.

Delay between pouring each lift. Upper section lighter than heavily mottled lower – consistent with impermeable formwork and heavy vibration.

Mottling discolouration caused by casting against smooth impermeable formwork with vibration

Discolouration caused by moisture loss at chamfer/form interface – ensure form joints do not leak.

Chamfer clean and well defined.

Tie-bolt holes generally clean and well defined.

Occasional irregular cavities lined with aggregate particles (at the-top), aggregate bridging, a function of coarse aggregate grading. Re-vibration of upper third may have minimised this.

*Overall finish considered Class F2.*

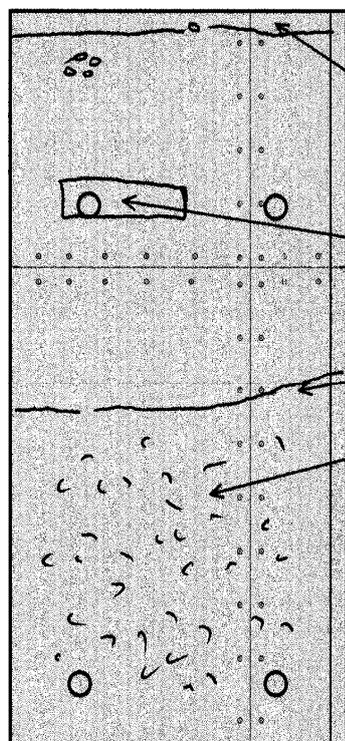
**Panel 2**                      Finish Class F4  
**Side 2**                      Steel plate formwork

Dusty surface caused by upper surface of wall not being covered to prevent moisture loss. Concrete shrinks away from form surface while immature, sometimes plucking concrete face, but leaving a dusty weakened surface – lack of early curing.

Discolouration caused by staking of panels with timber spacers locally affecting the curing compared to the rest of the panel that was open to air circulation.

Delay between pouring each lift. Upper section lighter than heavily mottled lower – consistent with impermeable formwork and heavy vibration.

Mottling discolouration caused by casting against smooth impermeable formwork with vibration.

Chamfer clean and well defined. Concrete reflects the sealant shape and some residue sealant visible – poor workmanship

Tie-bolt holes generally clean and well defined.

Occasional irregular cavities lined with aggregate particles (at the-top), aggregate bridging, a function of coarse aggregate grading. Re-vibration of upper third may have minimised this.

*Overall finish just considered Class F4, although marred colour variation. Improved attention to detail would rectify these blemishes.*

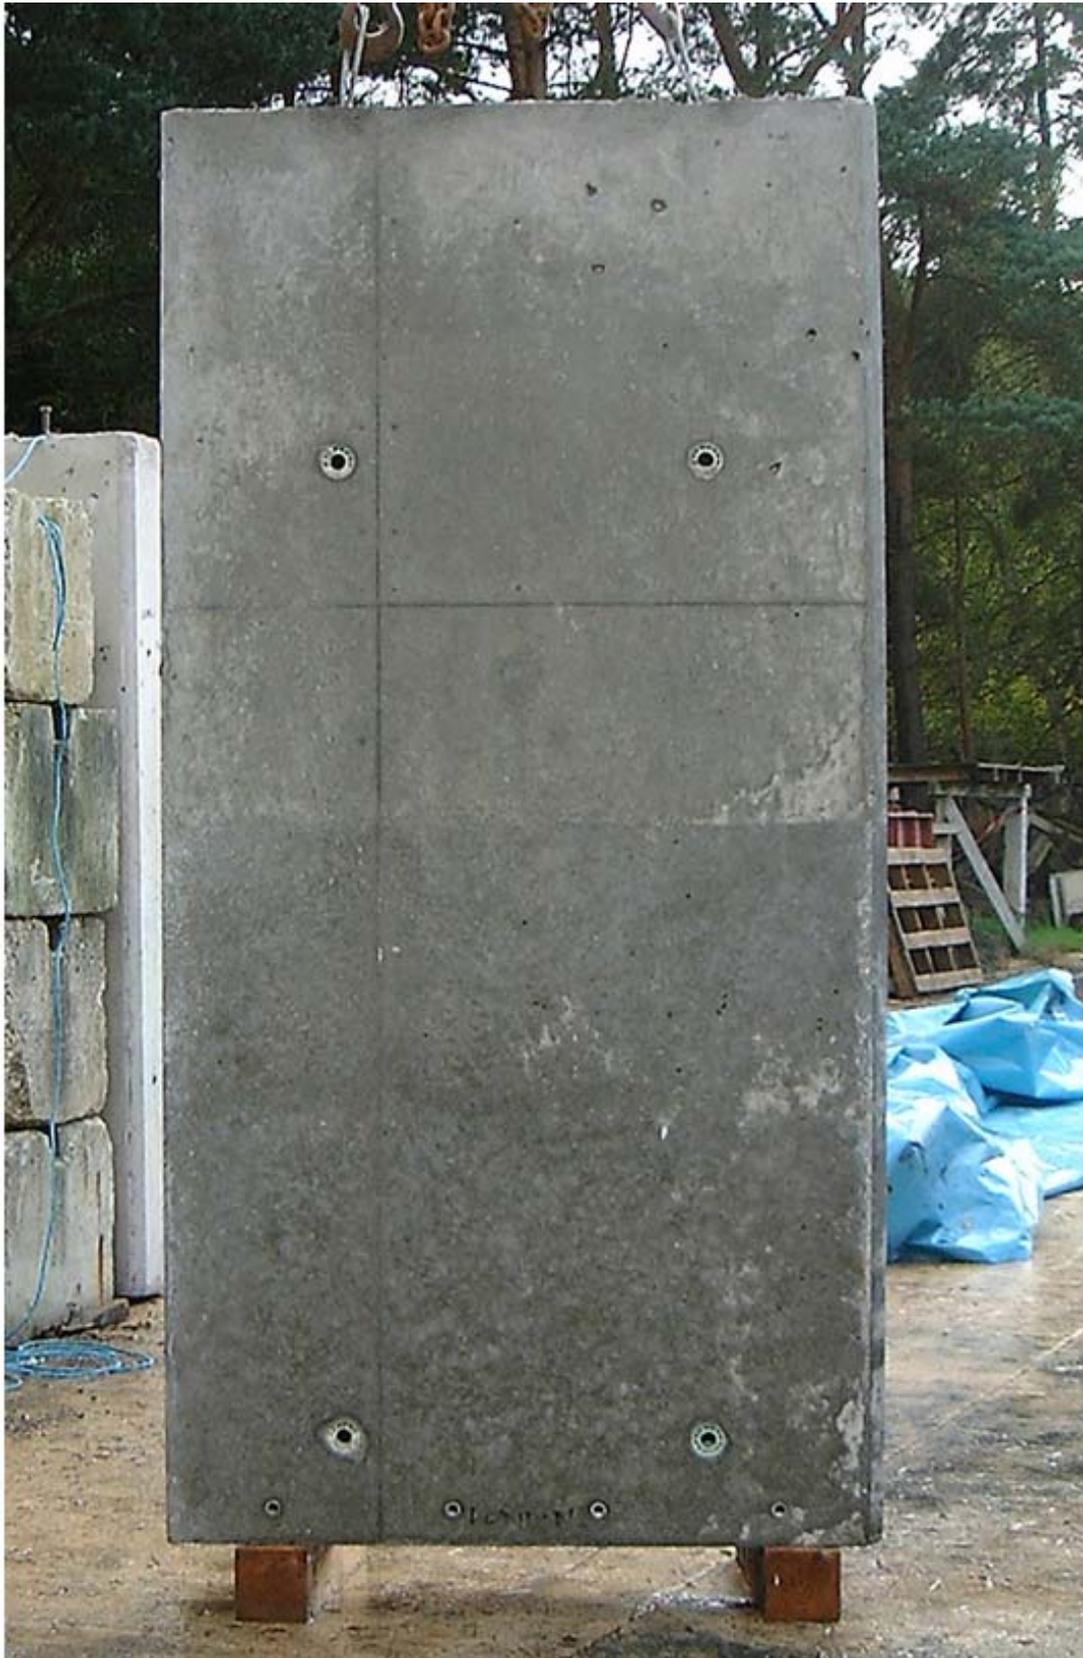
**Panel 2 –Side 1 - F2 finish**

A Class F2 finish as struck from the Steel plate form face. The butt joint between the sheets were not filled. Screw heads driven flush but were not filled and the edge chamfer was not sealed against form. An imprint of joints and screw heads is displayed as ridges and knobs, in a uniform pattern.

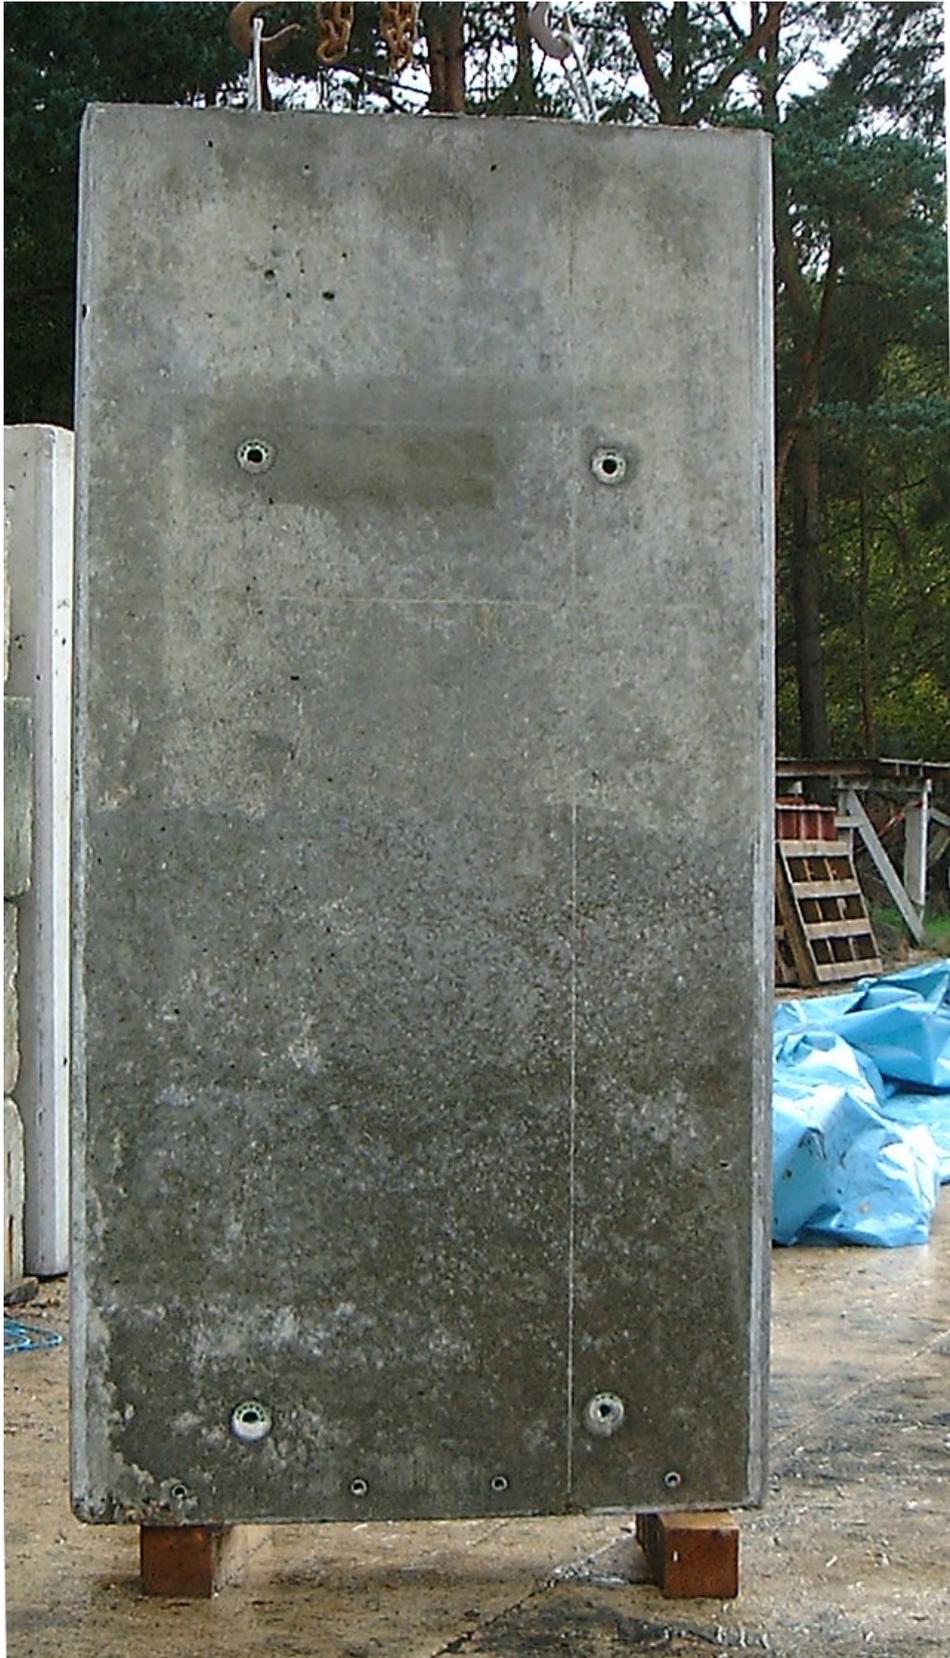
**Panel 2 – Side 2 - F4 finish**

A Class F4 finish as struck from the Steel plate form face. The butt joints between sheets were filled and sanded. The form joints were filled with a bead of silicon sealant, as was the edge chamfer. Screw heads were counter-sunk, filled and sanded. An impression of the joints and screw heads is flush and smooth. A colour variation exists due to the difference in absorption of fill material compared to that of form face.
